**Flood Control Project Maintenance
Levee Inspections****LMA District Cover Sheet****Spring 2014 Levee Inspection Results****American River Flood Control District**

Spring 2014 Levee Inspection Results

American River Flood Control District

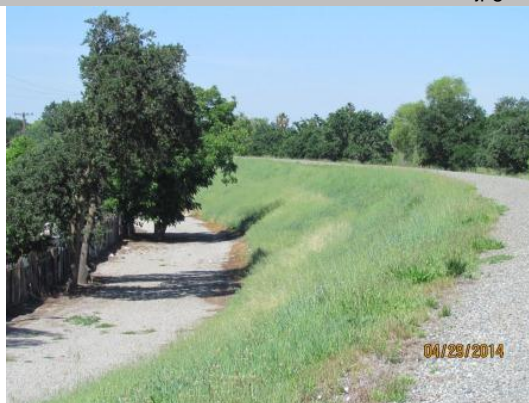
Photo 1 of 1 : mkhashch_s_20140508_00957.jpg

LM Start	0.03	Rating **	M	Issue No.	51
LM End	0.63	Issue Type +	Ma	Location *	LS
Category	Earthen Levee			GPS Latitude/Longitude	
				Start	End
Item	Vegetation			38.619578 °	38.623700 °
				-121.467128 °	-121.457672 °
DWR ID	DWR_NA0001_01_s _ 2014_51				
Action/Comments					
Control annual grass and weeds on the levee slopes and easements.

View of the annual vegetation on the landside levee slope.

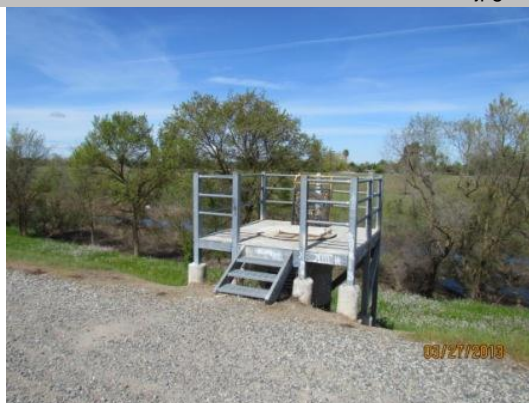
Photo 1 of 1 : mkhashch_s_20140428_00033.jpg

LM Start	0.40	Rating **	A/W	Issue No.	60
LM End	0.40	Issue Type +	Ma	Location *	WS
Category	Earthen Levee			GPS Latitude/Longitude	
				Start	End
Item	Encroachments			38.622579 °	38.622579 °
				-121.461567 °	-121.461567 °
DWR ID	DWR_NA0001_01_s _ 2012_60				
Action/Comments					
Pipe

View of the pipe at the waterside levee hinge.

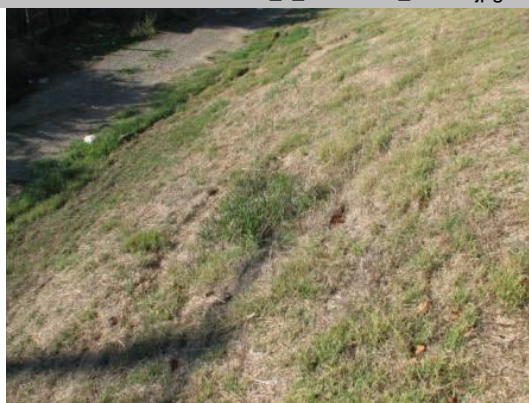
Photo 1 of 1 : mkhashch_s_20140428_00034.jpg

LM Start	0.48	Rating **	A/W	Issue No.	164
LM End	0.48	Issue Type +	Ma	Location *	LS
Category	Earthen Levee			GPS Latitude/Longitude	
				Start	End
Item	Erosion / Bank Caving			38.623227 °	38.623227 °
				-121.460399 °	-121.460399 °
DWR ID	DWR_NA0001_01_s _ 2012_164				
Action/Comments					
Note and monitor erosion site. Inspector Comments: 4'-5' diameter by 1' deep hole mid-slope on the landside.

11/17/2011 Hole/depression approximately mid-slope.

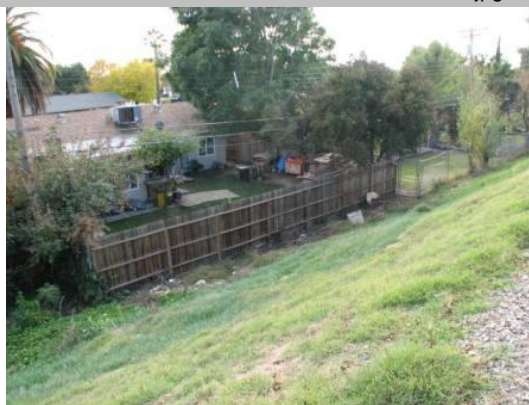
Photo 1 of 1 : mkhashch_s_20140428_00046.jpg

LM Start	0.77	Rating **	U	Issue No.	183
LM End	0.77	Issue Type +	En	Location *	LS
Category	Earthen Levee			GPS Latitude/Longitude	
				Start	End
Item	Encroachments			38.624016 °	38.624016 °
				-121.455193 °	-121.455193 °
DWR ID	DWR_NA0001_01_s _ 2012_183				
Action/Comments					
Fence					
Inspector Comments: Dog-eared fence built within 10' of the toe

11/17/2011 Wooden privacy fence.

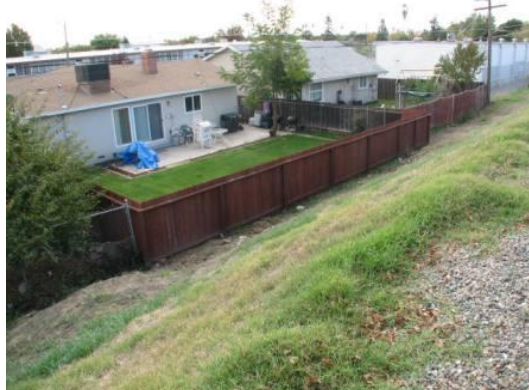
Photo 1 of 1 : mkhashch_s_20140428_00045.jpg

LM Start	0.95	Rating **	U	Issue No.	182
LM End	0.95	Issue Type +	En	Location *	LS
Category	Earthen Levee			GPS Latitude/Longitude	
				Start	End
Item	Encroachments			38.625072 °	38.625072 °
				-121.452225 °	-121.452225 °
DWR ID	DWR_NA0001_01_s_2012_182				
Action/Comments					
Fence Inspector Comments: Dog-eared wooden fence built within 10' of the toe.

11/17/2011 Wooden privacy fence built at the levee toe.

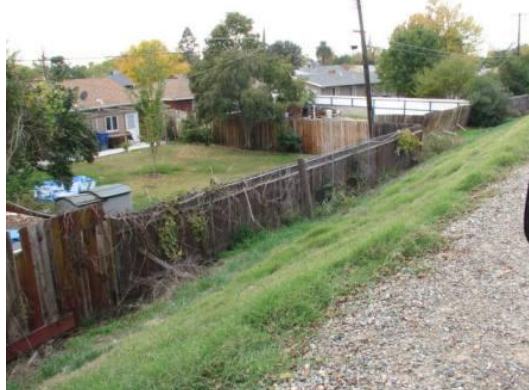
Photo 1 of 1 : mkhashch_s_20140428_00020.jpg

LM Start	1.16	Rating **	U	Issue No.	23
LM End	1.16	Issue Type +	En	Location *	LS
Category	Earthen Levee			GPS Latitude/Longitude	
				Start	End
Item	Encroachments			38.624832 °	38.624832 °
				-121.448607 °	-121.448607 °
DWR ID	DWR_NA0001_01_s_2012_23				
Action/Comments					
Fence Inspector Comments: Dog-eared wooden fence and chain link fence is built against the levee slope.

11/17/2011 Fence built on the levee slope.

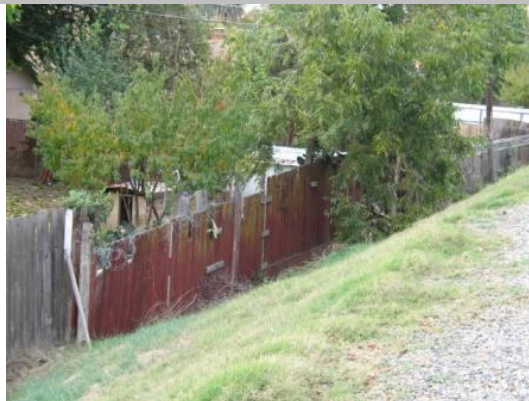
Photo 1 of 1 : mkhashch_s_20140428_00019.jpg

LM Start	1.17	Rating **	U	Issue No.	22
LM End	1.17	Issue Type +	En	Location *	LS
Category	Earthen Levee			GPS Latitude/Longitude	
				Start	End
Item	Encroachments			38.624850 °	38.624850 °
				-121.448428 °	-121.448428 °
DWR ID	DWR_NA0001_01_s _ 2012_22				
Action/Comments					
Fence Inspector Comments: Dog-eared wooden fence is built against the levee slope.

11/17/2011 Wooden privacy fence built at the levee toe.

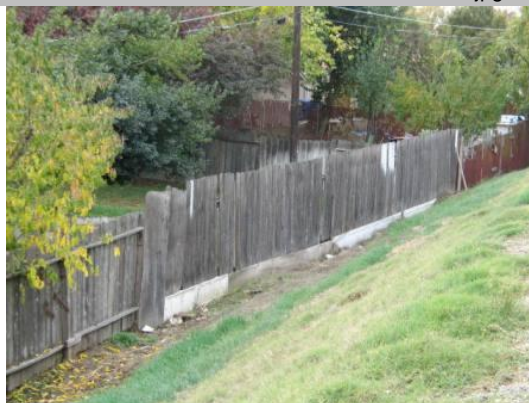
Photo 1 of 1 : mkhashch_s_20140428_00018.jpg

LM Start	1.18	Rating **	U	Issue No.	21
LM End	1.18	Issue Type +	En	Location *	LS
Category	Earthen Levee			GPS Latitude/Longitude	
				Start	End
Item	Encroachments			38.624877 °	38.624877 °
				-121.448248 °	-121.448248 °
DWR ID	DWR_NA0001_01_s _ 2012_21				
Action/Comments					
Fence Inspector Comments: Dog-eared wooden fence is built against the levee slope.

11/17/2011 Wooden privacy fence built at the levee toe.

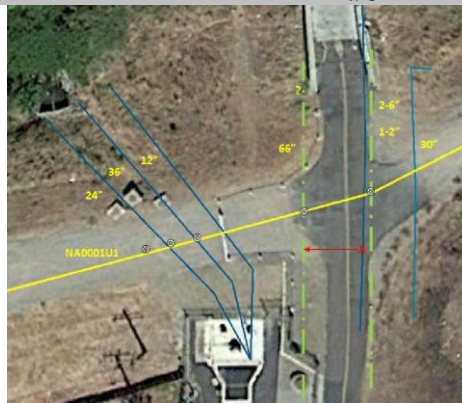
Photo 1 of 1 : UCIP_6315.jpg

UCIP Comments: Crossing is present in the layer provided by the City of Sacramento, however this crossing was not found in the field. Need to determine status of crossing. If crossing is no longer used, owner will need to coordinate with Central Valley Flood Protection Board to comply with Title 23.

Alignment indicated in blue is approximate locations for pipes that cross levee. Alignment information was obtained from the City of Sacramento.

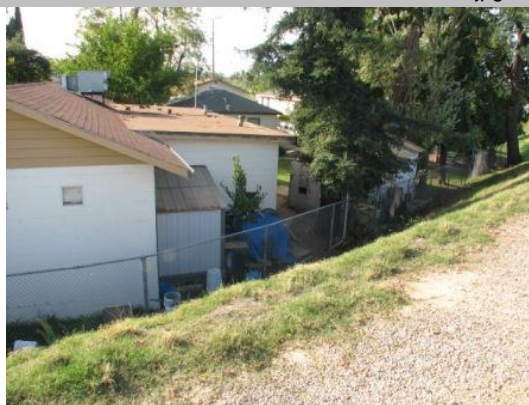
Photo 1 of 1 : mkhashch_s_20140428_00016.jpg

LM Start	1.26	Rating **	U	Issue No.	18
LM End	1.26	Issue Type +	En	Location *	LS
Category	Earthen Levee			GPS Latitude/Longitude	
				Start	End
Item	Encroachments			38.625300 °	38.625300 °
				-121.446767 °	-121.446767 °
DWR ID	DWR NA0001 01 s 2012 18

Inspector Comments: Cement block building within 10-ft of toe.

Fall 2009 photo: Buildings and fence near levee toe.

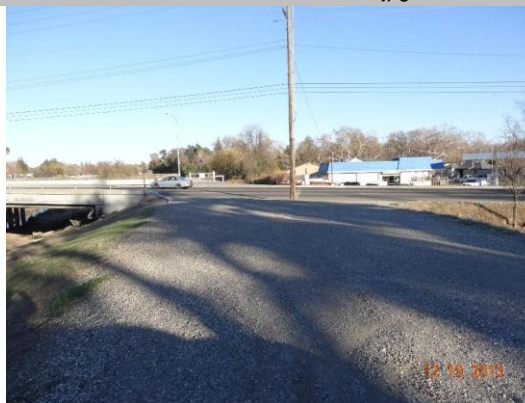
Photo 1 of 1 : UCIP_6273.jpg

LM Start	1.27	Rating **	M	Issue No.	40
LM End	1.27	Issue Type +	En	Location *	LS
Category	Supplemental			GPS Latitude/Longitude	
				Start	End
Item	DWR UCIP Field Study			38.625500 °	38.625500 °
				-121.446390 °	-121.446390 °
DWR ID	DWR_NA0001_01_s_2014_40				
Action/Comments					
Inspector Comments: FS_ID:30085					
EP_NO: N/A					
Repair Type:					
Crossing Status:					
UCIP Comments: Unable to confirm location--will need to coordinate with owner to determine if crossing is still active and determine location.					
FIELD_STRUCT_DESC: 1 of 3: 16-inch pipe through the levee, 8.0 feet below the crown. Floodgates within the levee across the channel, installed under Permit No. 14480 (1986).					
FS Date: 12/19/2013

Overview of levee crown at crossing.

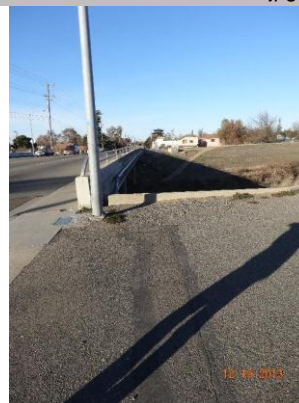
Photo 1 of 1 : UCIP_6225.jpg

LM Start	1.30	Rating **	M	Issue No.	42
LM End	1.30	Issue Type +	En	Location *	LS
Category	Supplemental			GPS Latitude/Longitude	
				Start	End
Item	DWR UCIP Field Study			38.625603 °	38.625603 °
				-121.446035 °	-121.446035 °
DWR ID	DWR_NA0001_01_s_2014_42				
Action/Comments					
Inspector Comments: FS_ID:29734					
EP_NO: 15152					
Repair Type:					
Crossing Status:					
UCIP Comments: Need to confirm if this crossing is gas line. Need to contact owner to determine status of crossing (active or inactive) and to determine last inspection date. Will need copy of letter showing crossings passed inspection. Missing utility markers.					
FIELD_STRUCT_DESC: 4-inch (appears to be 4.5 or 5 inches instead of 4 inches) steel gas main through the levee, 2.5 feet below the crown.					
Vent on the waterward shoulder. (Permit No. 15152-1989)					
FS Date: 12/19/2013

View of levee crown with repair signs at crossing.

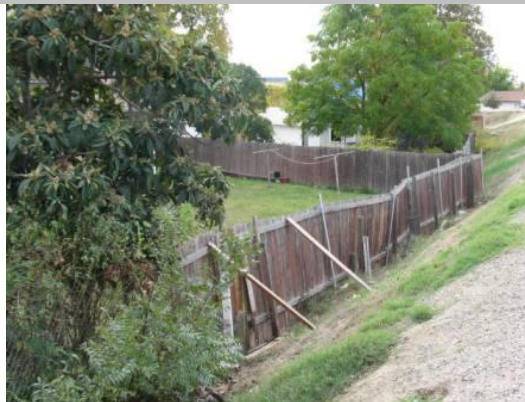
Photo 1 of 1 : mkhashch_s_20140428_00015.jpg

LM Start	1.34	Rating **	U	Issue No.	17
LM End	1.34	Issue Type +	En	Location *	LS
Category	Earthen Levee			GPS Latitude/Longitude	
				Start	End
Item	Encroachments			38.625901 °	38.625901 °
				-121.445393 °	-121.445393 °
DWR ID	DWR_NA0001_01_s_2012_17				
Action/Comments					
Fence					
Inspector Comments: Wooden privacy fence

11/17/2011 Wooden privacy fence built at the levee toe. Levee slope is being used to support the fence.

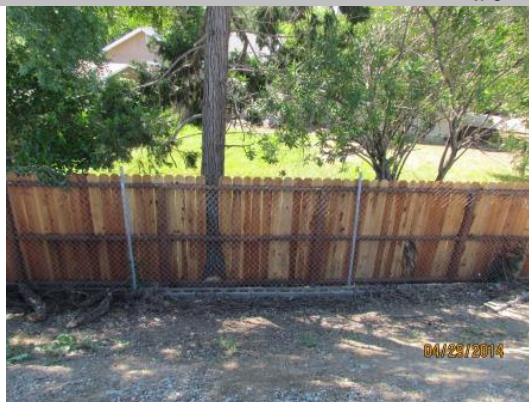
Photo 1 of 1 : mkhashch_s_20140508_00956.jpg

LM Start	1.35	Rating **	U	Issue No.	50
LM End	1.35	Issue Type +	En	Location *	LS
Category	Earthen Levee			GPS Latitude/Longitude	
				Start	End
Item	Encroachments			38.625982 °	38.625982 °
				-121.445231 °	-121.445231 °
DWR ID	DWR_NA0001_01_s_2014_50				
Action/Comments					
Fence

View of the fence at the landside levee toe obstructing visibility and access.

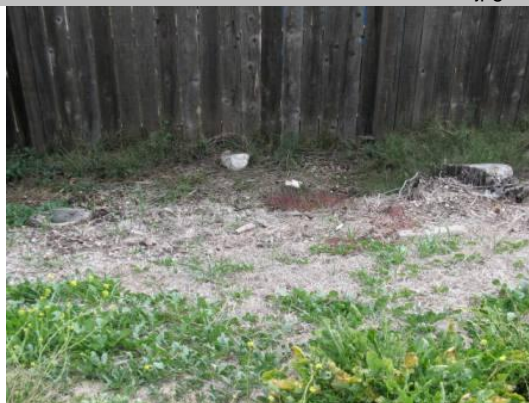
Photo 1 of 1 : mkhashch_s_20140428_00044.jpg

LM Start	1.35	Rating **	N	Issue No.	178
LM End	1.35	Issue Type +	Ma	Location *	LS
Category	Earthen Levee			GPS Latitude/Longitude	
				Start	End
Item	Trim / Thin Trees			38.626063 °	38.626063 °
				-121.444988 °	-121.444988 °
DWR ID	DWR_NA0001_01_s_2012_178				
Action/Comments					
Tree stumps. Inspector Comments: Two stumps at landside toe.

11/17/2011 Two stumps at levee toe.

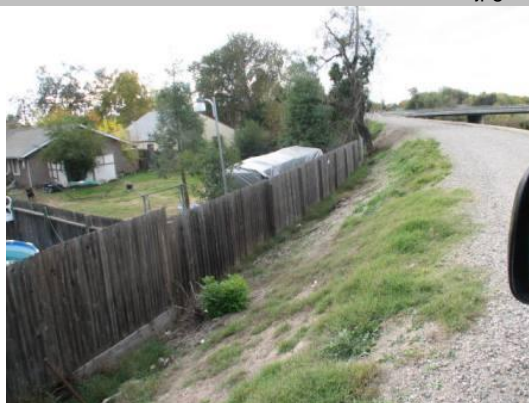
Photo 1 of 1 : mkhashch_s_20140428_00014.jpg

LM Start	1.37	Rating **	U	Issue No.	16
LM End	1.37	Issue Type +	En	Location *	LS
Category	Earthen Levee			GPS Latitude/Longitude	
				Start	End
Item	Encroachments			38.626000 °	38.626000 °
				-121.444978 °	-121.444978 °
DWR ID	DWR_NA0001_01_s _ 2012_16				
Action/Comments					
Fence					
Inspector Comments: Wooden privacy fence

11/17/2011 Wooden privacy fence built at the levee toe.

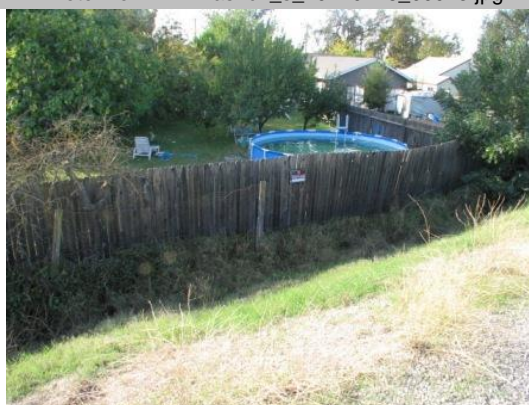
Photo 1 of 1 : mkhashch_s_20140428_00013.jpg

LM Start	1.38	Rating **	U	Issue No.	15
LM End	1.38	Issue Type +	En	Location *	LS
Category	Earthen Levee			GPS Latitude/Longitude	
				Start	End
Item	Encroachments			38.626048 °	38.626048 °
				-121.444785 °	-121.444785 °
DWR ID	DWR_NA0001_01_s _ 2012_15				
Action/Comments					
Fence					
Inspector Comments: Wooden privacy fence with vine on levee slope.

Fall 2009 photo: Wooden and wire fence are within 10-ft of levee toe.

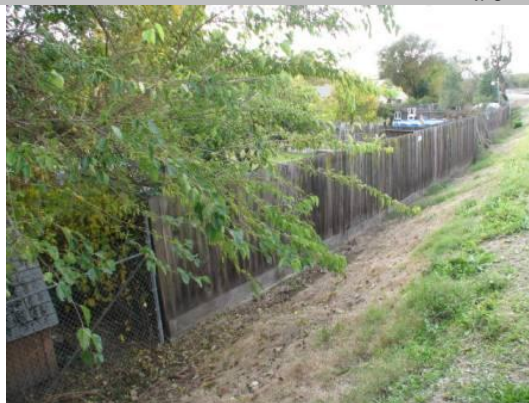
Photo 1 of 1 : mkhashch_s_20140428_00012.jpg

LM Start	1.39	Rating **	U	Issue No.	14
LM End	1.39	Issue Type +	En	Location *	LS
Category	Earthen Levee			GPS Latitude/Longitude	
				Start	End
Item	Encroachments			38.626085 °	38.626085 °
				-121.444580 °	-121.444580 °
DWR ID	DWR_NA0001_01_s _ 2012_14				
Action/Comments					
Fence					
Inspector Comments: Wooden privacy fence

11/17/2011 Wooden privacy fence built at the levee toe.

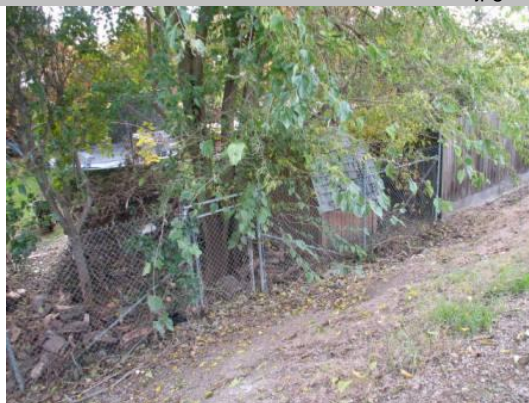
Photo 1 of 1 : mkhashch_s_20140428_00030.jpg

LM Start	1.40	Rating **	M	Issue No.	38
LM End	1.40	Issue Type +	En	Location *	LS
Category	Earthen Levee			GPS Latitude/Longitude	
				Start	End
Item	Encroachments			38.626210 °	38.626210 °
				-121.444320 °	-121.444320 °
DWR ID	DWR_NA0001_01_s _ 2012_38				
Action/Comments					
Building					
Inspector Comments: Small wooden storage shed and firewood are placed along chain link fence within 10-ft of levee toe.

11/17/2011 Shed and firewood can be seen through the chainlink fence.

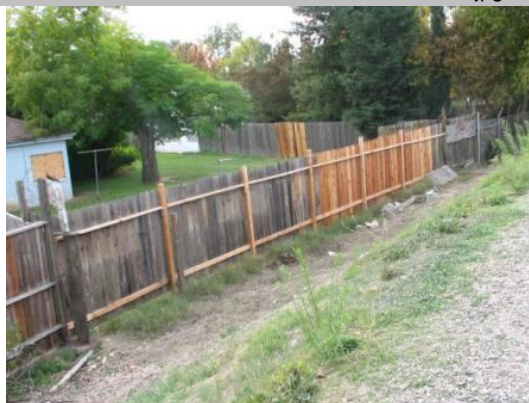
Photo 1 of 1 : mkhashch_s_20140428_00011.jpg

LM Start	1.41	Rating **	U	Issue No.	13
LM End	1.41	Issue Type +	En	Location *	LS
Category	Earthen Levee			GPS Latitude/Longitude	
				Start	End
Item	Encroachments			38.626155 °	38.626155 °
				-121.444250 °	-121.444250 °
DWR ID	DWR_NA0001_01_s _ 2012_13				
Action/Comments					
Fence Inspector Comments: Wooden fence with barbed wire is built within 10-ft of levee toe. 04/13/2011 Fence has blown over and now partially rests on the levee. Fall insp 2011 fence has been rebuilt in same location, within 10' of levee toe.

11/17/2011 New wooden privacy fence built within 15' of the levee toe.

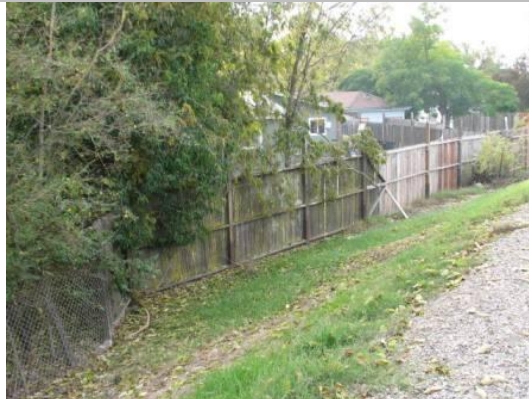
Photo 1 of 1 : mkhashch_s_20140428_00010.jpg

LM Start	1.42	Rating **	U	Issue No.	12
LM End	1.42	Issue Type +	En	Location *	LS
Category	Earthen Levee			GPS Latitude/Longitude	
				Start	End
Item	Encroachments			38.626212 °	38.626212 °
				-121.444082 °	-121.444082 °
DWR ID	DWR_NA0001_01_s _ 2012_12				
Action/Comments					
Fence Inspector Comments: Dog-eared wooden fence is built near the levee slope.

11/17/2011 Wooden privacy fence built within 15' of the levee toe.

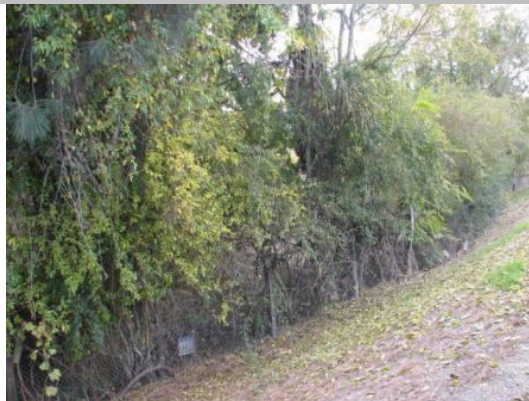
Photo 1 of 1 : mkhashch_s_20140428_00043.jpg

LM Start	1.43	Rating **	U	Issue No.	177
LM End	1.43	Issue Type +	En	Location *	LS
Category	Earthen Levee			GPS Latitude/Longitude	
				Start	End
Item	Vegetation			38.626429 °	38.626429 °
				-121.443835 °	-121.443835 °
DWR ID	DWR_NA0001_01_s _ 2012_177				
Action/Comments					
Landscaping Inspector Comments: Thick vegetation at the toe.

11/17/2011 Thick vegetation at the levee toe.

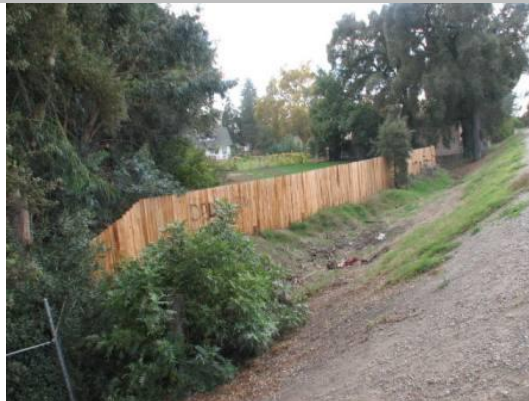
Photo 1 of 1 : mkhashch_s_20140428_00042.jpg

LM Start	1.48	Rating **	U	Issue No.	176
LM End	1.48	Issue Type +	En	Location *	LS
Category	Earthen Levee			GPS Latitude/Longitude	
				Start	End
Item	Encroachments			38.626881 °	38.626881 °
				-121.443253 °	-121.443253 °
DWR ID	DWR_NA0001_01_s _ 2012_176				
Action/Comments					
Fence Inspector Comments: Wooden privacy fence within 10' of the levee toe.

11/17/2011 Wooden privacy fence built within 15' of the levee toe.

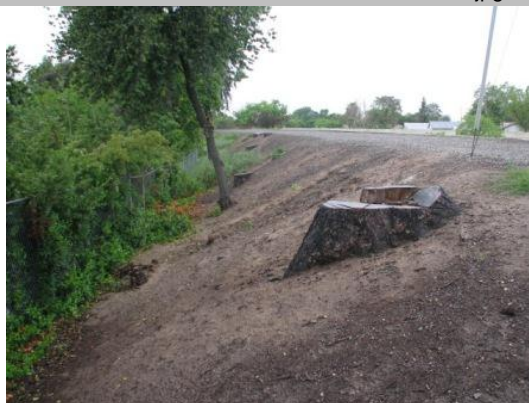
Photo 1 of 1 : mkhashch_s_20140428_00032.jpg

LM Start	1.52	Rating **	N	Issue No.	56
LM End	1.52	Issue Type +	Ma	Location *	LS
Category	Earthen Levee			GPS Latitude/Longitude	
				Start	End
Item	Trim / Thin Trees			38.627224 °	38.627224 °
				-121.442515 °	-121.442515 °
DWR ID	DWR_NA0001_01_s _ 2012_56				
Action/Comments					
Tree stumps. Inspector Comments: 5 stumps 14 to 30 Inches in diameter.

Several large stumps on levee slope.

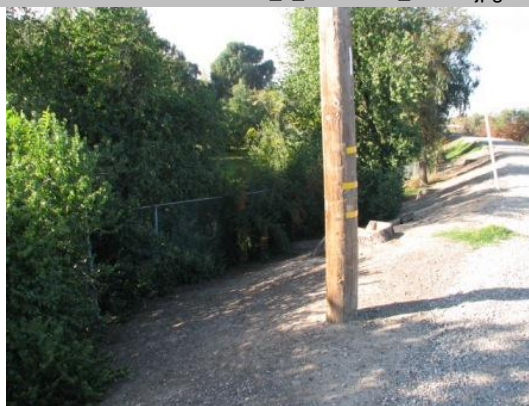
Photo 1 of 1 : mkhashch_s_20140428_00028.jpg

LM Start	1.54	Rating **	M	Issue No.	35
LM End	1.54	Issue Type +	En	Location *	LS
Category	Earthen Levee			GPS Latitude/Longitude	
				Start	End
Item	Vegetation			38.627281 °	38.627281 °
				-121.442203 °	-121.442203 °
DWR ID	DWR_NA0001_01_s _ 2012_35				
Action/Comments					
Landscaping Inspector Comments: Bushes and trees along chain link fence block access and visibility.

Fall 2009 photo:Vegetation obstructing visibility near levee slope.

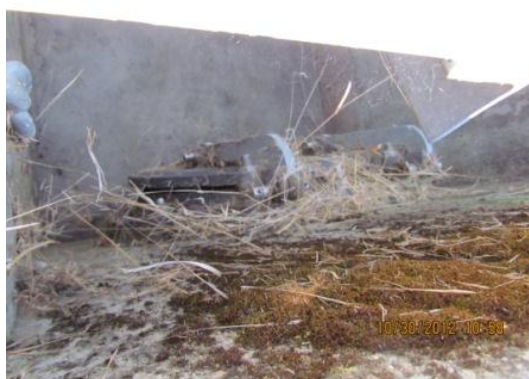
Photo 1 of 1 : mkhashch_s_20140428_00041.jpg

LM Start	1.58	Rating **	A/W	Issue No.	174
LM End	1.58	Issue Type +	Ma	Location *	WS
Category	Earthen Levee			GPS Latitude/Longitude	
				Start	End
Item	Encroachments			38.627244 °	38.627244 °
				-121.441462 °	-121.441462 °
DWR ID	DWR_NA0001_01_s_2012_174				
Action/Comments					
Pipe					
Inspector Comments: Flap gate appeared to be closed.

View of flap gate.

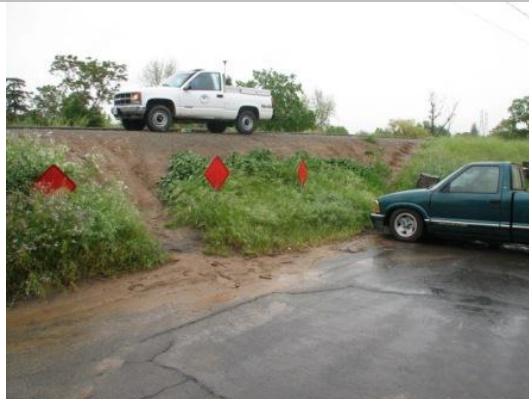
Photo 1 of 1 : mkhashch_s_20140428_00031.jpg

LM Start	1.58	Rating **	A/W	Issue No.	54
LM End	1.58	Issue Type +	Ma	Location *	LS
Category	Earthen Levee			GPS Latitude/Longitude	
				Start	End
Item	Slope Stability			38.627251 °	38.627251 °
				-121.441460 °	-121.441460 °
DWR ID	DWR_NA0001_01_s _ 2012_54				
Action/Comments					
Repair the levee slope damaged by foot traffic and prevent access where possible.

Slope stability due to foot traffic needs to be monitored.

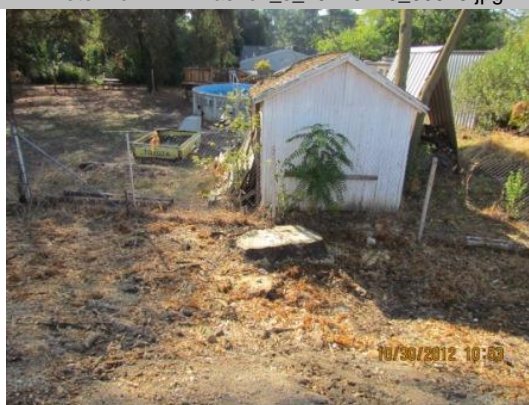
Photo 1 of 1 : mkhashch_s_20140428_00025.jpg

LM Start	1.59	Rating **	N	Issue No.	31
LM End	1.59	Issue Type +	Ma	Location *	LS
Category	Earthen Levee			GPS Latitude/Longitude	
				Start	End
Item	Trim / Thin Trees			38.627335 °	38.627335 °
				-121.441172 °	-121.441172 °
DWR ID	DWR_NA0001_01_f _ 2012_31				
Action/Comments					
Tree stumps.

View of large tree stump at levee toe.

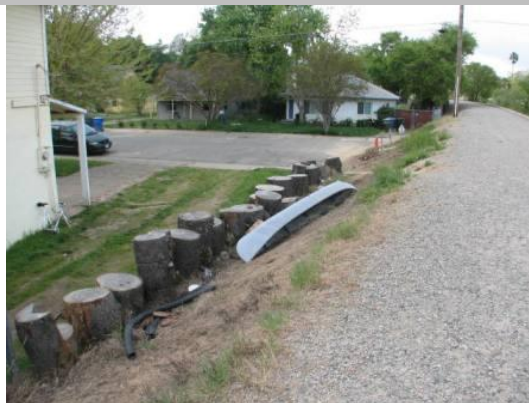
Photo 1 of 1 : mkhashch_s_20140428_00029.jpg

LM Start	1.59	Rating **	M	Issue No.	37
LM End	1.59	Issue Type +	En	Location *	LS
Category	Earthen Levee			GPS Latitude/Longitude	
				Start	End
Item	Encroachments			38.627215 °	38.627215 °
				-121.441218 °	-121.441218 °
DWR ID	DWR_NA0001_01_s _ 2012_37				
Action/Comments					
Debris Inspector Comments: Wood rounds and some pieces of pipe may be being stored on levee, need to be removed.

04/13/2011 Items appear to be stored on levee, need to be removed.

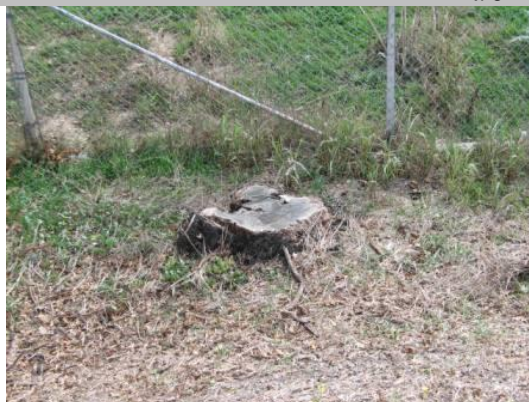
Photo 1 of 1 : mkhashch_s_20140428_00040.jpg

LM Start	1.65	Rating **	N	Issue No.	173
LM End	1.65	Issue Type +	Ma	Location *	LS
Category	Earthen Levee			GPS Latitude/Longitude	
				Start	End
Item	Trim / Thin Trees			38.627297 °	38.627297 °
				-121.440188 °	-121.440188 °
DWR ID	DWR_NA0001_01_s _ 2012_173				
Action/Comments					
Tree stumps. Inspector Comments: Large stump at levee toe.

11/17/2011 Stump at levee toe.

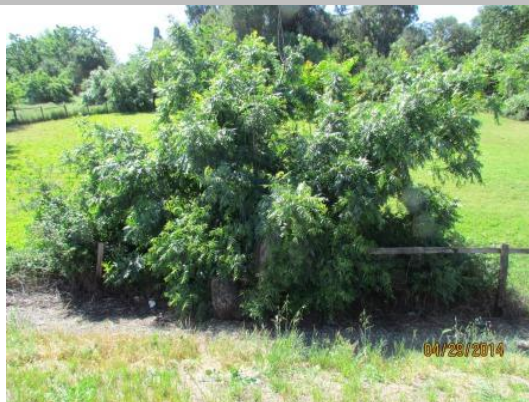
Photo 1 of 1 : mkhashch_s_20140508_00955.jpg

LM Start	1.69	Rating **	A/W	Issue No.	48
LM End	1.69	Issue Type +	Ma	Location *	LS
Category	Earthen Levee			GPS Latitude/Longitude	
				Start	End
Item	Vegetation			38.627594 °	38.627594 °
				-121.439540 °	-121.439540 °
DWR ID	DWR_NA0001_01_s _ 2014_48				
Action/Comments					
Trees / Woody Vegetation					
Inspector Comments: Tree obstructing visibility and access.

View of the overgrown tree at the landside levee toe.

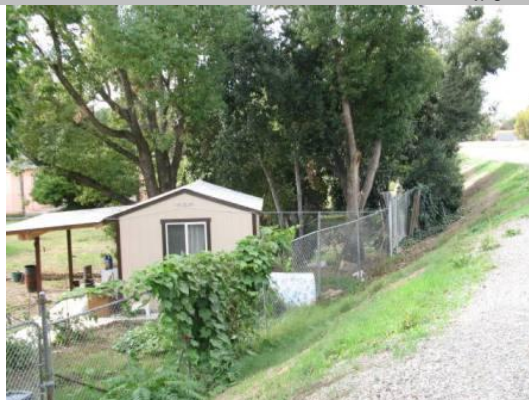
Photo 1 of 1 : mkhashch_s_20140428_00038.jpg

LM Start	1.82	Rating **	U	Issue No.	169
LM End	1.82	Issue Type +	En	Location *	LS
Category	Earthen Levee			GPS Latitude/Longitude	
				Start	End
Item	Encroachments			38.627914 °	38.627914 °
				-121.437263 °	-121.437263 °
DWR ID	DWR_NA0001_01_s_2012_169				
Action/Comments					
Building Inspector Comments: Shed on concrete pad within 10' of the levee toe.

11/17/2011 Wooden shed on concrete pad built within 15' of levee toe.

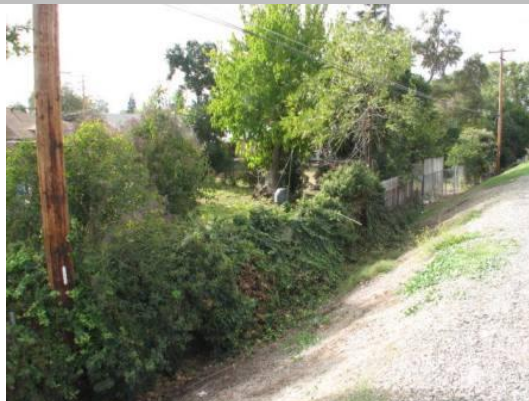
Photo 1 of 1 : mkhashch_s_20140428_00007.jpg

LM Start	1.85	Rating **	M	Issue No.	8
LM End	1.85	Issue Type +	En	Location *	LS
Category	Earthen Levee			GPS Latitude/Longitude	
				Start	End
Item	Vegetation			38.627889 °	38.627889 °
				-121.436638 °	-121.436638 °
DWR ID	DWR_NA0001_01_s _ 2012_8				
Action/Comments					
Landscaping Inspector Comments: Ivy, trees and other landscaping growing on a wooden privacy fence are obstructing visibility.

11/17/2011 Landscaping vegetation growth on the fence is obstructive.

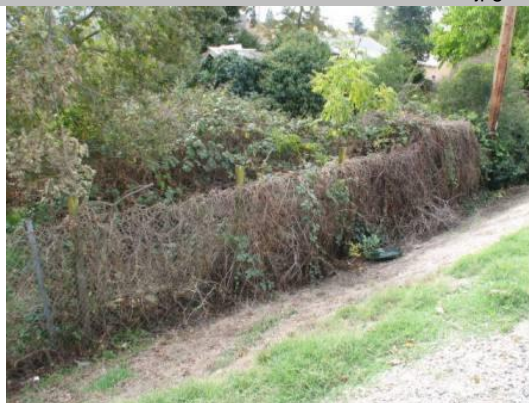
Photo 1 of 1 : mkhashch_s_20140428_00006.jpg

LM Start	1.86	Rating **	U	Issue No.	7
LM End	1.86	Issue Type +	En	Location *	LS
Category	Earthen Levee			GPS Latitude/Longitude	
				Start	End
Item	Vegetation			38.627889 °	38.627889 °
				-121.436454 °	-121.436454 °
DWR ID	DWR_NA0001_01_s _ 2012_7				
Action/Comments					
Landscaping Inspector Comments: Metal sided shelter, blackberries and cherry trees are obstructive.

11/17/2011 Blackberries growing on fence are obstructive.

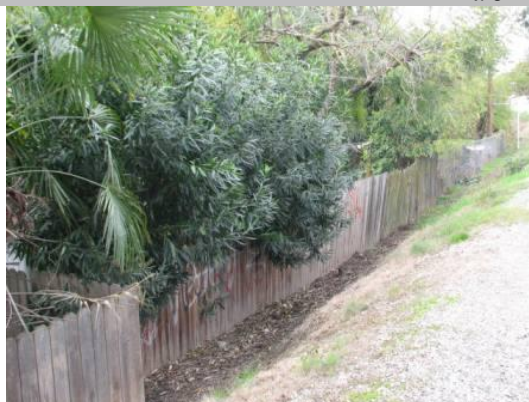
Photo 1 of 1 : mkhashch_s_20140428_00005.jpg

LM Start	1.92	Rating **	U	Issue No.	6
LM End	1.92	Issue Type +	En	Location *	LS
Category	Earthen Levee			GPS Latitude/Longitude	
				Start	End
Item	Encroachments			38.627725 °	38.627725 °
				-121.435715 °	-121.435715 °
DWR ID	DWR_NA0001_01_s _ 2012_6				
Action/Comments					
Fence Inspector Comments: Dog-eared wooden fence is built within 10-ft of the levee slope.

11/17/2011 Wooden privacy fence built at the levee toe.

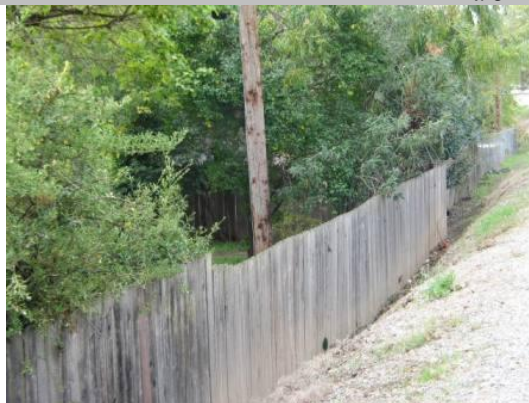
Photo 1 of 1 : mkhashch_s_20140428_00004.jpg

LM Start	1.93	Rating **	U	Issue No.	5
LM End	1.93	Issue Type +	En	Location *	LS
Category	Earthen Levee			GPS Latitude/Longitude	
				Start	End
Item	Encroachments			38.627680 °	38.627680 °
				-121.435555 °	-121.435555 °
DWR ID	DWR_NA0001_01_s_2012_5				
Action/Comments					
Fence Inspector Comments: Dog-eared wooden fence is built against the levee slope.

11/17/2011 Wooden privacy fence built at the levee toe.

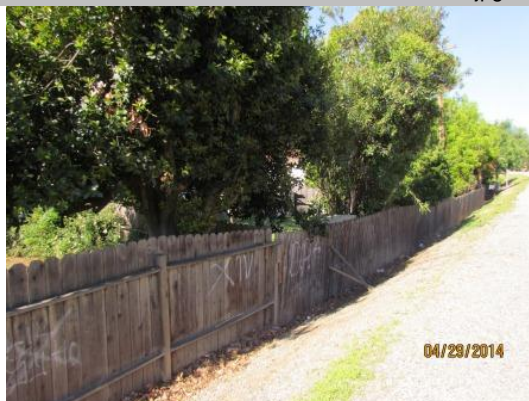
Photo 1 of 1 : mkhashch_s_20140508_00954.jpg

LM Start	1.93	Rating **	U	Issue No.	4
LM End	1.93	Issue Type +	En	Location *	LS
Category	Earthen Levee			GPS Latitude/Longitude	
				Start	End
Item	Encroachments			38.627683 °	38.627683 °
				-121.435298 °	-121.435298 °
DWR ID	DWR_NA0001_01_s_2012_4				
Action/Comments					
Fence Inspector Comments: Wooden fence and landscaping completely block visibility.

View of the wooden fence at the landside levee toe.

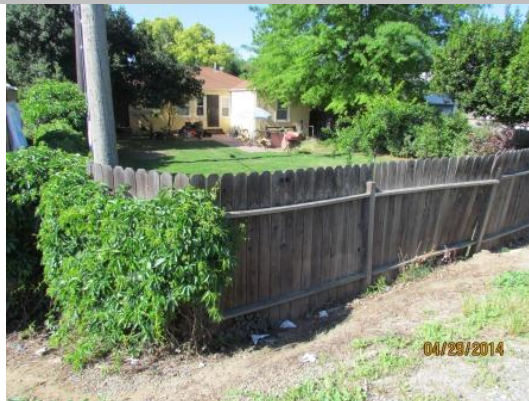
Photo 1 of 1 : mkhashch_s_20140508_00953.jpg

LM Start	1.93	Rating **	U	Issue No.	3
LM End	1.93	Issue Type +	En	Location *	LS
Category	Earthen Levee			GPS Latitude/Longitude	
				Start	End
Item	Encroachments			38.627658 °	38.627658 °
				-121.435192 °	-121.435192 °
DWR ID	DWR_NA0001_01_s _ 2012_3				
Action/Comments					
Fence Inspector Comments: Dog-eared wooden fence is built against the levee slope.

View of the fence at the landside levee toe.

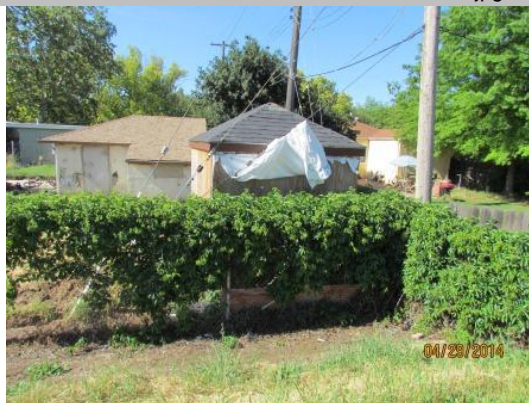
Photo 1 of 1 : mkhashch_s_20140505_00952.jpg

LM Start	1.94	Rating **	U	Issue No.	30
LM End	1.94	Issue Type +	En	Location *	LS
Category	Earthen Levee			GPS Latitude/Longitude	
				Start	End
Item	Encroachments			38.627646 °	38.627646 °
				-121.435151 °	-121.435151 °
DWR ID	DWR_NA0001_01_s _ 2012_30				
Action/Comments					
Building Inspector Comments: Concrete pad and wooden frame structure is being built within 15-ft of levee toe.

Building on concrete pad within 15 feet of the landside levee toe.

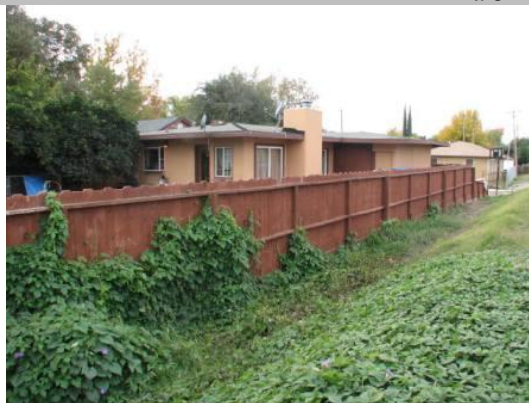
Photo 1 of 1 : mkhashch_s_20140428_00036.jpg

LM Start	1.98	Rating **	U	Issue No.	167
LM End	1.98	Issue Type +	En	Location *	LS
Category	Earthen Levee			GPS Latitude/Longitude	
				Start	End
Item	Encroachments			38.627433 °	38.627433 °
				-121.434341 °	-121.434341 °
DWR ID	DWR_NA0001_01_s _ 2012_167				
Action/Comments					
Fence					
Inspector Comments: Wooden privacy fence within 10' of the levee toe.

11/17/2011 Wooden privacy fence built at the levee toe.

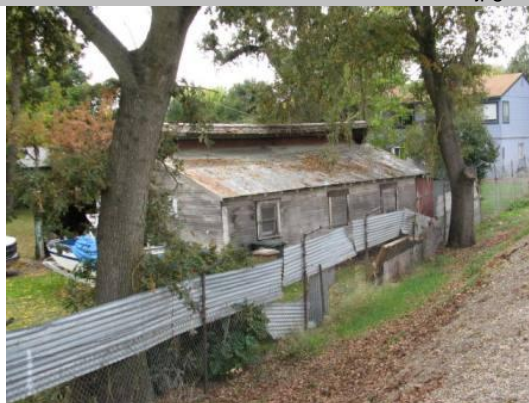
Photo 1 of 1 : mkhashch_s_20140428_00022.jpg

LM Start	2.04	Rating **	U	Issue No.	28
LM End	2.04	Issue Type +	En	Location *	LS
Category	Earthen Levee			GPS Latitude/Longitude	
				Start	End
Item	Encroachments			38.627257 °	38.627257 °
				-121.433327 °	-121.433327 °
DWR ID	DWR_NA0001_01_s _ 2012_28				
Action/Comments					
Building Inspector Comments: Large wooden building behind corrugated metal covered fence is within 10-ft of levee toe.

11/17/2011 Wooden structure is within 15' of the levee toe.

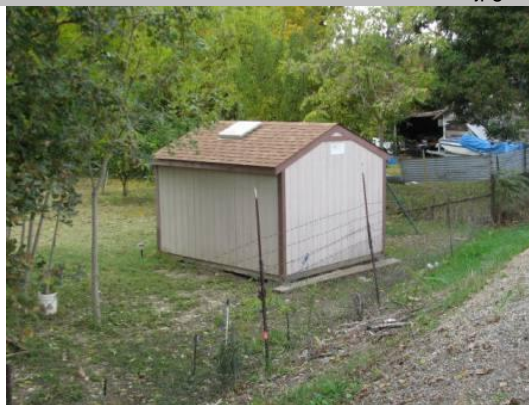
Photo 1 of 1 : mkhashch_s_20140428_00021.jpg

LM Start	2.05	Rating **	M	Issue No.	27
LM End	2.05	Issue Type +	En	Location *	LS
Category	Earthen Levee			GPS Latitude/Longitude	
				Start	End
Item	Encroachments			38.627230 °	38.627230 °
				-121.433039 °	-121.433039 °
DWR ID	DWR_NA0001_01_s _ 2012_27				
Action/Comments					
Building Inspector Comments: Pre-fab storage shed is within 10-ft of landside toe.

11/17/2011 Wooden structure is within 15' of the levee toe.

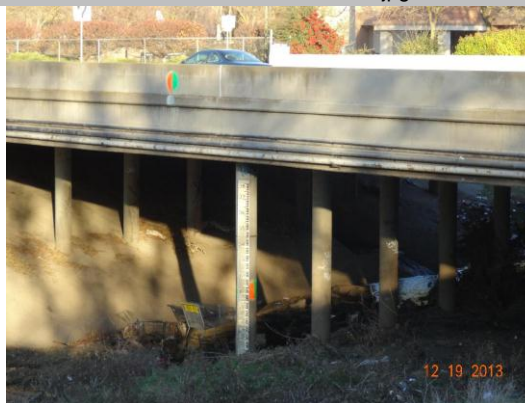
Photo 1 of 1 : UCIP_6330.jpg

LM Start	2.08	Rating **	M	Issue No.	46
LM End	2.08	Issue Type +	En	Location *	LS
Category	Supplemental			GPS Latitude/Longitude	
				Start	End
Item	DWR UCIP Field Study			38.627239 °	38.627239 °
				-121.432501 °	-121.432501 °
DWR ID	DWR_NA0001_01_s _ 2014_46				
Action/Comments					
Inspector Comments: FS_ID:31185					
EP_NO: 13044					
Repair Type:					
Crossing Status:					
UCIP Comments: Orange/Green symbol for flood structure found on floodwall. No crossing found. Need to determine if crossing is in use. This crossing is not shown in the City of Sacramento's sewer drain mains or water mains. Need to contact owner to determine if crossing is still in use.					
FIELD_STRUCT_DESC: 12-inch steel water main through the levee, 4.0 feet below the crown. (Permit No. 13044-1981)					
FS Date: 12/19/2013

Markers visible of crossing on bridge.

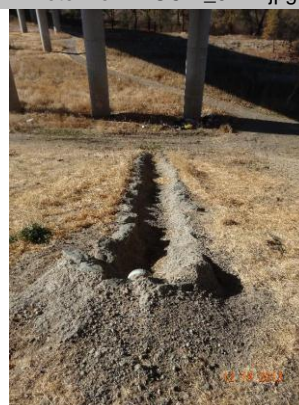
Photo 1 of 1 : UCIP_6417.jpg

LM Start	0.32	Rating **	M	Issue No.	9
LM End	0.32	Issue Type +	En	Location *	WS
Category	Supplemental			GPS Latitude/Longitude	
				Start	End
Item	DWR UCIP Field Study			38.606204 °	38.606204 °
				-121.467817 °	-121.467817 °
DWR ID	DWR_NA0001_02_s_2014_9				
Action/Comments					
Inspector Comments: FS_ID:31443					
EP_NO: N/A					
Repair Type:					
Crossing Status:					
UCIP Comments: no permit (unauthorize crossing)--need to determine additional information about crossing. Unable to determine if pipe crosses levee.					
FIELD_STRUCT_DESC: 4-inch HDPE pipe through levee at unknown depth.					
FS Date: 12/6/2013

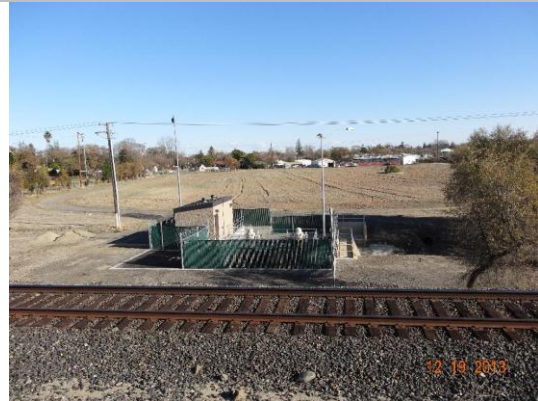
Photo 1 of 1 : UCIP_6130.jpg

UCIP Comments: Multiple pumps visible on landward side however unable to confirm additional crossing only 1 crossing was confirmed at this location. Need to contact owner to determine status of crossing.
FIELD_STRUCT_DESC: 24-inch pipe sleeved through 30-inch CM pipe through the levee, 2.8 feet below the crown. Annular gap grouted. Flap gate on waterward end. Slide gate in concrete pipe riser at waterward toe. Pump on structure over concrete sump on landward side. (USACE-1959). This entry matches the Drainage or Irrigation Structure referenced in O&M manual (Station 216+00).
FS Date: 12/19/2013

Overview of pumps located on landward side.

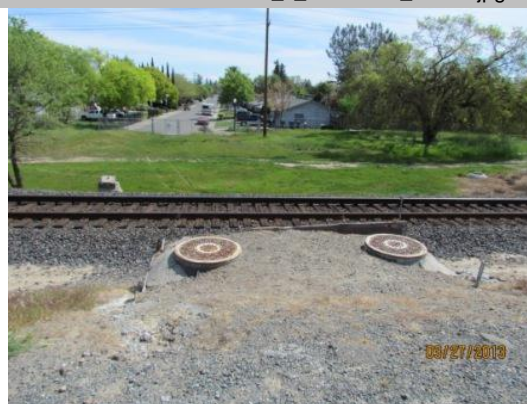
Photo 1 of 1 : mkhashch_s_20140428_00056.jpg

Action/Comments					
Pipe Inspector Comments: Manhole access to pipes on hinge point.

View of the pipe access at the landside levee hinge.

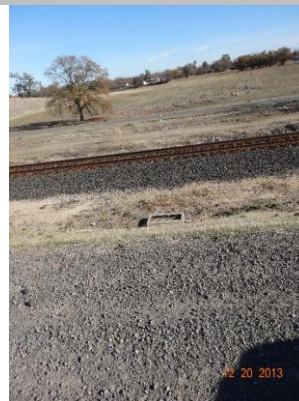
Photo 1 of 1 : UCIP_6151.jpg

LM Start	1.95	Rating **	M	Issue No.	19
LM End	1.95	Issue Type +	En	Location *	CR
Category	Supplemental			GPS Latitude/Longitude	
				Start	End
Item	DWR UCIP Field Study			38.629129 °	38.629129 °
				-121.469556 °	-121.469556 °
DWR ID	DWR_NA0001_02_s_2014_19				
Action/Comments					
Inspector Comments: FS_ID:28667					
EP_NO: N/A					
Repair Type:					
Crossing Status:					
UCIP Comments: Only found concrete box located on landward side toe. Need to contact owner to determine if crossing goes through levee and to notify that concrete box is filled with debris.					
FIELD_STRUCT_DESC: 12-inch CM railroad drainpipe through the levee. (USACE-1959). This entry matches the Drainage or Irrigation Structure referenced in O&M manual (Station 302+00).					
FS Date: 12/20/2013

View of landward side. Depression visible at levee toe around concrete box.

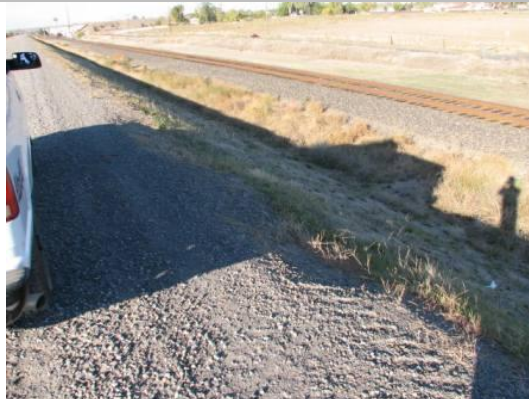
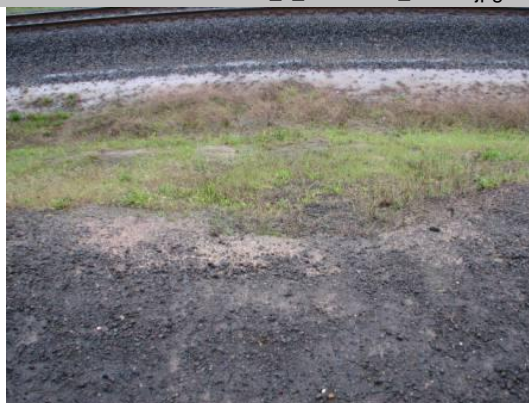
Photo 1 of 2 : mkhashch_s_20140428_00058.jpg

LM Start	2.33	Rating **	A/W	Issue No.	150
LM End	2.33	Issue Type +	Ob	Location *	LS
Category	Earthen Levee			GPS Latitude/Longitude	
				Start	End
Item	Erosion / Bank Caving			38.634446 °	38.634446 °
				-121.470573 °	-121.470573 °
DWR ID	DWR_NA0001_02_s_2012_150				
Action/Comments					
Note and monitor erosion site. Inspector Comments: Monitor erosion at this location. Also noted in USACE PI.

11/16/2011 Depressions present on levee slope.

03/14/2012 Photo shows depression, the issue has not gotten any worse since the fall 2011 inspection.

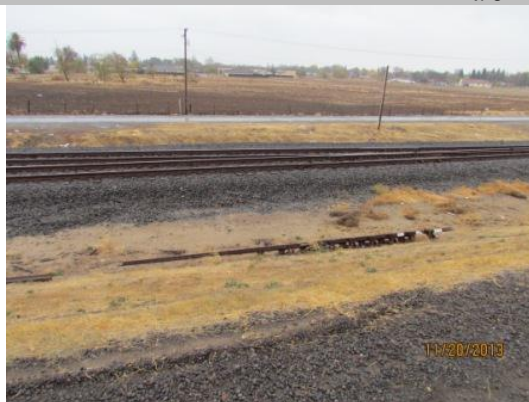
Photo 1 of 1 : mkhashch_s_20140428_00057.jpg

LM Start	2.52	Rating **	M	Issue No.	11
LM End	2.52	Issue Type +	En	Location *	LS
Category	Earthen Levee			GPS Latitude/Longitude	
				Start	End
Item	Encroachments			38.637177 °	38.637177 °
				-121.471076 °	-121.471076 °
DWR ID	DWR_NA0001_02_f_2013_11				
Action/Comments					
Material

View of the rails at the landside levee toe.

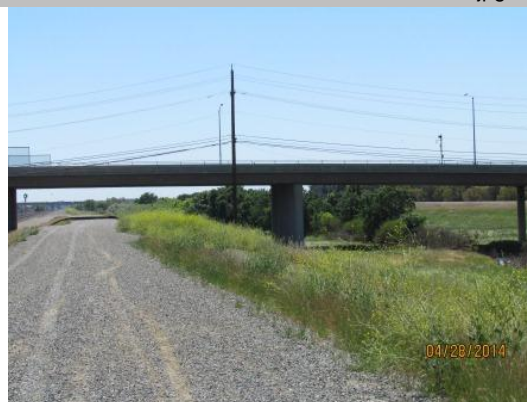
Photo 1 of 1 : mkhashch_s_20140505_00943.jpg

LM Start	2.83	Rating **	M	Issue No.	24
LM End	3.90	Issue Type +	Ma	Location *	WS
Category	Earthen Levee			GPS Latitude/Longitude	
				Start	End
Item	Vegetation			38.641623 °	38.656787 °
				-121.471958 °	-121.474821 °
DWR ID	DWR_NA0001_02_s _ 2014_24				
Action/Comments					
Control annual grass and weeds on the levee slopes and easements.

View of tall vegetation on waterside levee slope.

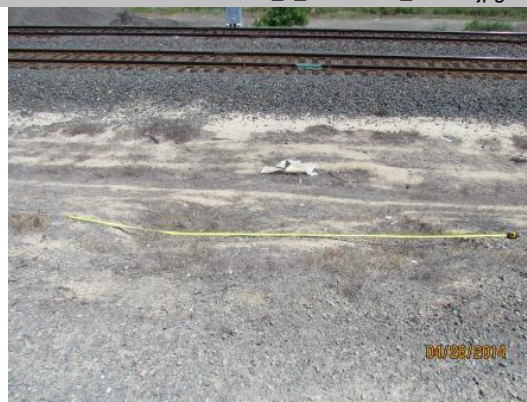
Photo 1 of 1 : mkhashch_s_20140505_00942.jpg

LM Start	2.93	Rating **	A/W	Issue No.	6
LM End	2.93	Issue Type +	Ob	Location *	LS
Category	Earthen Levee			GPS Latitude/Longitude	
				Start	End
Item	Slope Stability			38.642950 °	38.642950 °
				-121.472166 °	-121.472166 °
DWR ID	DWR_NA0001_02_f_2012_6				
Action/Comments					
Repair slope instability.					
Inspector Comments: Monitor this location.

View of landside slope instability.

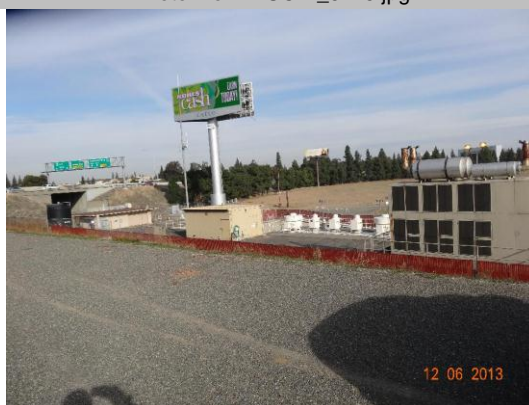
Photo 1 of 1 : UCIP_6175.jpg

View of landward side.

LM Start	1.53	Rating **	M	Issue No.	15
LM End	1.53	Issue Type +	En	Location *	LS
Category	Supplemental			GPS Latitude/Longitude	
				Start	End
Item	DWR UCIP Field Study			38.593224 °	38.593224 °
				-121.444299 °	-121.444299 °
DWR ID	DWR_NA0001_03_s _ 2014_15				
Action/Comments					
Inspector Comments: FS_ID:31227					
EP_NO: 2805					
Repair Type:					
Crossing Status:					
UCIP Comments: Unable to confirm what crossings are going through levee. Will need to coordinate with owner to determine active crossings.					
FIELD_STRUCT_DESC: [Arden Treatment Plant] 1 of 4: 18-inch concrete sewer main through the levee. Concrete cutoff wall around pipe under center of levee. Siphon breaker in housing on waterward shoulder. Treatment plant on landward side. (Permit No. 2805-1961)					
FS Date: 12/3/2013

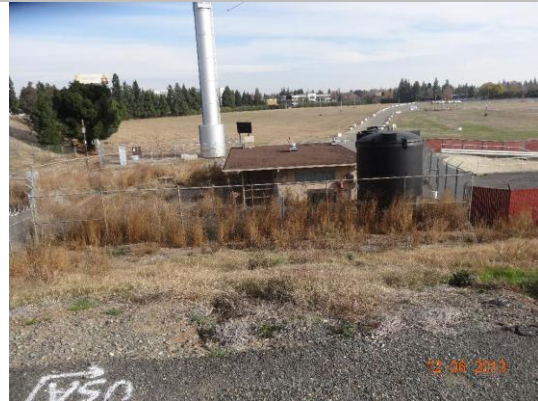
Photo 1 of 1 : UCIP_6353.jpg

View of landward side.

LM Start	1.53	Rating **	M	Issue No.	16
LM End	1.53	Issue Type +	En	Location *	LS
Category	Supplemental			GPS Latitude/Longitude	
				Start	End
Item	DWR UCIP Field Study			38.593224 °	38.593224 °
				-121.444299 °	-121.444299 °
DWR ID	DWR_NA0001_03_s _ 2014_16				
Action/Comments					
Inspector Comments: FS_ID:31223					
EP_NO: 2805					
Repair Type:					
Crossing Status:					
UCIP Comments: Unable to confirm what crossings are going through levee. Will need to coordinate iwth owner to determine active crossings.					
FIELD_STRUCT_DESC: [Arden Treatment Plant] 2 of 4: 8-inch iron sewer main through the levee, 2.5 feet below the crown. Concrete cutoff wall around pipe under center of levee. Siphon breaker in housing at waterward shoulder. Treatment plant on landward side. (Permit No. 6216-1969)					
FS Date: 12/3/2013

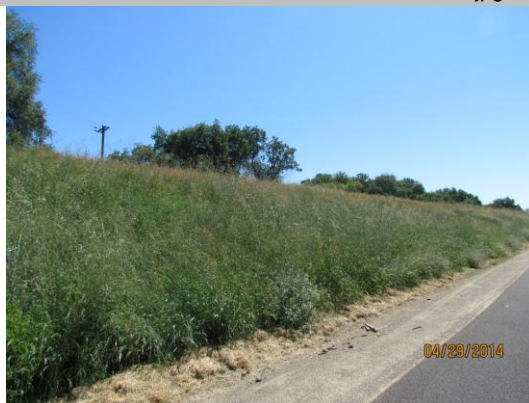
Photo 1 of 1 : mkhashch_s_20140508_00958.jpg

LM Start	2.31	Rating **	U	Issue No.	23
LM End	3.10	Issue Type +	Ma	Location *	WS
Category	Earthen Levee			GPS Latitude/Longitude	
				Start	End
Item	Vegetation			38.595956 °	38.598500 °
				-121.457509 °	-121.469862 °
DWR ID	DWR_NA0001_03_s_2014_23				
Action/Comments					
Control annual grass and weeds on the levee slopes and easements. Inspector Comments: LMA indicates that vegetation maintenance for this section is under USACE responsibility until completion of project.

View of tall vegetation on waterside levee slope.

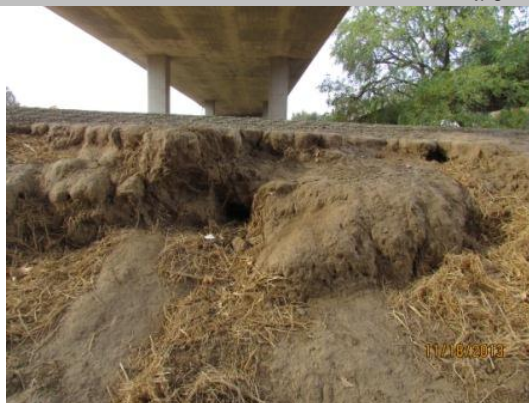
Photo 1 of 1 : mkhashch_s_20140428_00065.jpg

LM Start	3.14	Rating **	M	Issue No.	1
LM End	3.14	Issue Type +	Ma	Location *	LS
Category	Earthen Levee			GPS Latitude/Longitude	
				Start	End
Item	Animal Control			38.599141 °	38.599141 °
				-121.470227 °	-121.470227 °
DWR ID	DWR_NA0001_03_f_2013_1				
Action/Comments					
No rodents visible, but rodent burrows visible; need to backfill and compact or grout burrows.

View of the rodent holes on the landside levee slope.

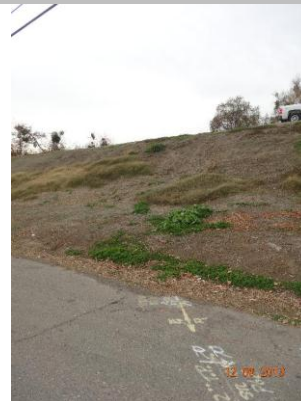
Photo 1 of 1 : UCIP_6179.jpg

LM Start	3.25	Rating **	M	Issue No.	22
LM End	3.25	Issue Type +	En	Location *	LS
Category	Supplemental			GPS Latitude/Longitude	
				Start	End
Item	DWR UCIP Field Study			38.600718 °	38.600718 °
				-121.471491 °	-121.471491 °
DWR ID	DWR_NA0001_03_s _ 2014_22				
Action/Comments					
Inspector Comments: FS_ID:28988					
EP_NO: N/A					
Repair Type:					
Crossing Status:					
UCIP Comments: Need to contact owner to determine status of crossing. Markers missing.					
FIELD_STRUCT_DESC: 12-inch gas line through the levee. Provide a field description of this crossing.					
FS Date: 12/3/2013

View of waterward side slope and USA paint markings indicating alignment.

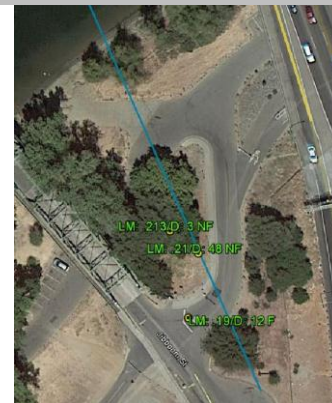
Photo 1 of 1 : UCIP_6190.jpg

LM Start	0.21	Rating **	M	Issue No.	50
LM End	0.21	Issue Type +	En	Location *	LS
Category	Supplemental			GPS Latitude/Longitude	
				Start	End
Item	DWR UCIP Field Study			38.598982 °	38.598982 °
				-121.505045 °	-121.505045 °
DWR ID	DWR_NA0001_04_s_2014_50				
Action/Comments					
Inspector Comments: FS_ID:29006					
EP_NO: 17171					
Repair Type:					
Crossing Status:					
UCIP Comments: Unable to find any indications that crossing is still active. Will need to contact owner to determine status of crossing.					
FIELD_STRUCT_DESC: 48-inch steel water line through the levee, approximately 32.0 feet below the crown. Siphon and blowoff valves in concrete riser on the landward side. (Permit No. 17171-2001)					
FS Date: 12/19/2013

Approximate alignment provided by the City of Sacramento--crossing not found during field visit.

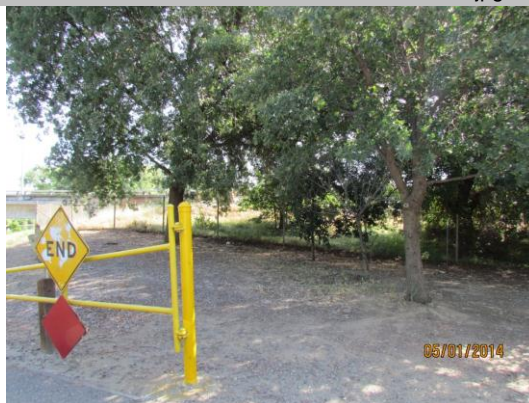
Photo 1 of 1 : mkhashch_s_20140509_00977.jpg

LM Start	0.23	Rating **	M	Issue No.	177
LM End	0.23	Issue Type +	En	Location *	CR
Category	Earthen Levee			GPS Latitude/Longitude	
				Start	End
Item	Vegetation			38.598980 °	38.598980 °
				-121.504773 °	-121.504773 °
DWR ID	DWR_NA0001_04_s _ 2012_177				
Action/Comments					
Landscaping					
Inspector Comments: Landscaping on levee crown at overpass.

View of the landscaping on the levee crown.

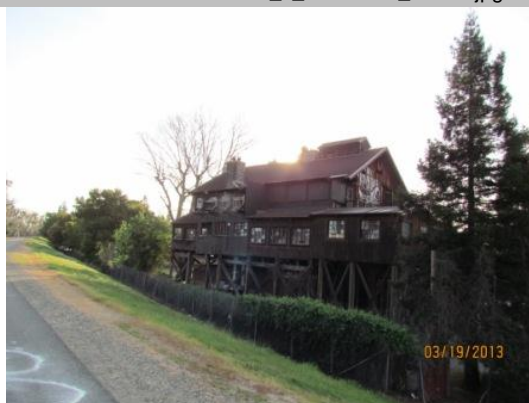
Photo 1 of 1 : mkhashch_s_20140428_00073.jpg

LM Start	0.32	Rating **	M	Issue No.	1
LM End	0.46	Issue Type +	En	Location *	LS
Category	Earthen Levee			GPS Latitude/Longitude	
				Start	End
Item	Vegetation			38.599835 °	38.600769 °
				-121.503448 °	-121.501133 °
DWR ID	DWR_NA0001_04_s _ 2012_1				
Action/Comments					
Landscaping					
Inspector Comments: Vines and privacy fence within 10-ft of the landside toe or on the levee slope obstruct visibility and access.

View of the vines obstructing visibility.

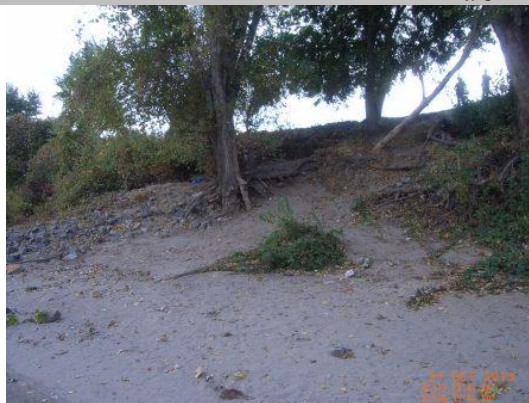
Photo 1 of 1 : USACE2013A_LAR_1-8_L_2.jpg

LM Start	1.62	Rating **	M	Issue No.	7
LM End	1.62	Issue Type +	Ma	Location *	WS
Category	Supplemental			GPS Latitude/Longitude	
				Start	End
Item	USACE Erosion Survey			38.599095 °	38.598791 °
				-121.480337 °	-121.479799 °
DWR ID					
Action/Comments					
Inspector Comments: 2012 - Located just downstream of older repair. Failing rock at the upstream end. Erosion of the bank has exposed large tree roots. 2013: No observed changes. [2013 Site ID: LAR_1-8_L]

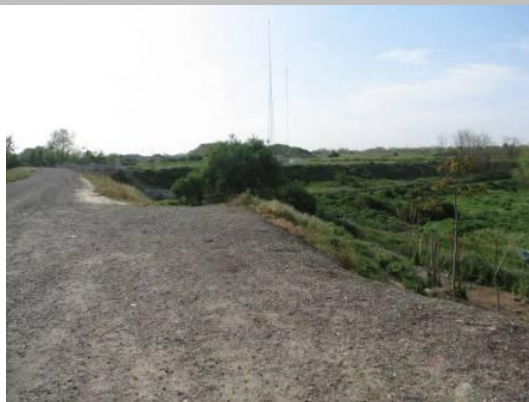
Photo 1 of 1 : mkhashch_s_20140428_00235.jpg

LM Start	2.50	Rating **	M	Issue No.	184
LM End	2.50	Issue Type +	Ma	Location *	LS
Category	Earthen Levee			GPS Latitude/Longitude	
				Start	End
Item	Vegetation			38.589590 °	38.589590 °
				-121.470524 °	-121.470524 °
DWR ID	DWR_NA0001_04_s _ 2012_184				
Action/Comments					
Elderberries are blocking visibility and flood fight capability.

04/14/2011 Elderberry bush prevents visibility of levee toe.

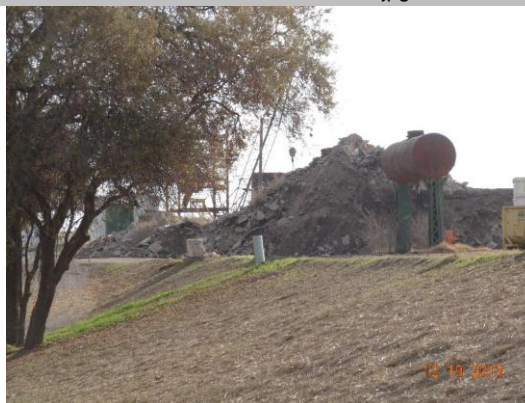
Photo 1 of 1 : UCIP_6421.jpg

LM Start	2.78	Rating **	M	Issue No.	214
LM End	2.78	Issue Type +	En	Location *	CR
Category	Supplemental			GPS Latitude/Longitude	
				Start	End
Item	DWR UCIP Field Study			38.587629 °	38.587629 °
				-121.465905 °	-121.465905 °
DWR ID	DWR_NA0001_04_s_2014_214				
Action/Comments					
Inspector Comments: FS_ID:31444					
EP_NO: N/A					
Repair Type:					
Crossing Status:					
UCIP Comments: No permit (unauthorized crossing)--need additional information about crossing.					
FIELD_STRUCT_DESC: Standpipe located on waterward shoulder.					
Unable to confirm pipe alignment. No permit found.					
FS Date: 12/19/2013

Standpipe located on waterward shoulder.
